**Docket No. 217 – Development and Management Plan Inspection**

**Date:** June 20, 2005

**Inspector:** Diana Walden

**Location:** 345kV XLPE Component

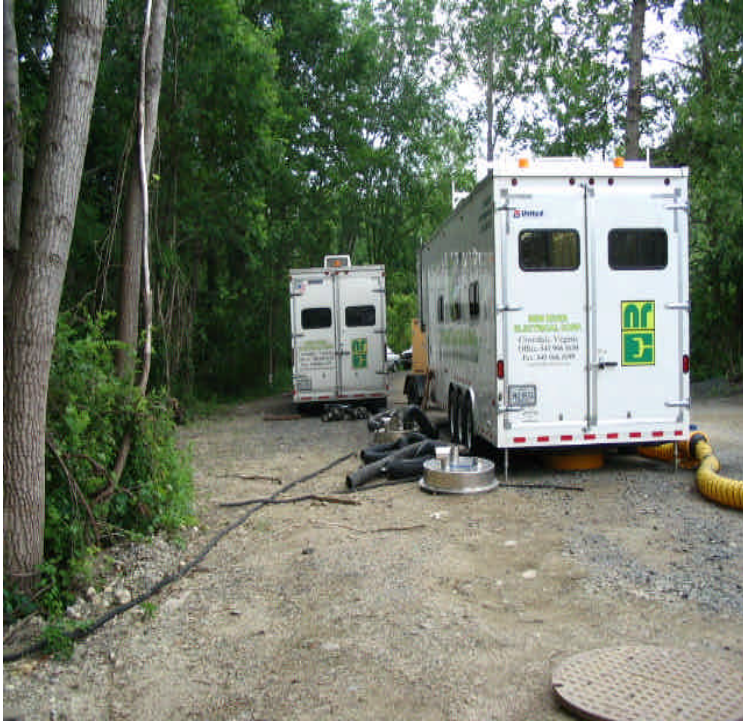
**345kV XLPE: Photo on the left shows the vault access adjacent to Plumtree Substation. Filter bags are on site if needed for dewatering. Photo on the right shows the crane set up on a pad in order to install the sheet piling in the stream. ACOE clearance was obtained. 6/20/06**

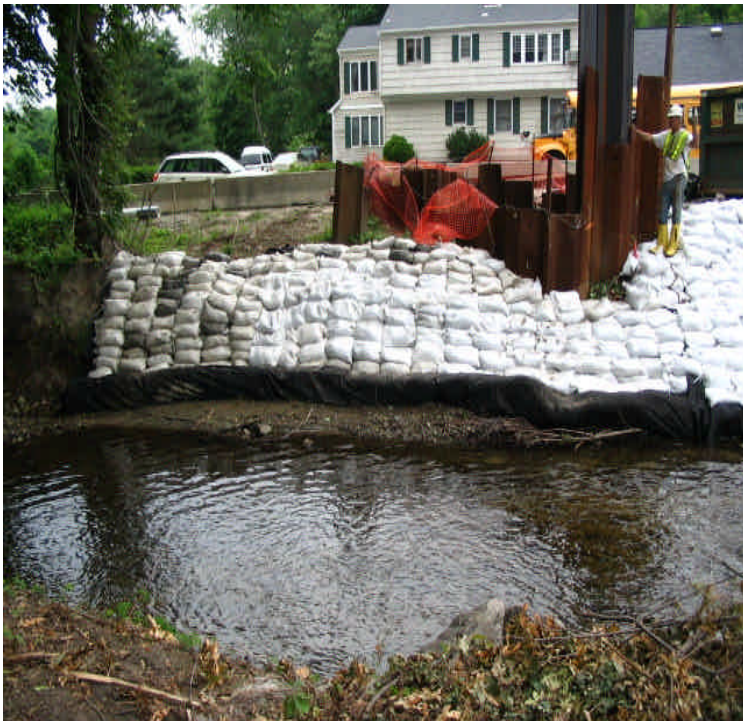
**Photo on the left shows the stream bank lined and reinforced with sand bags for the in-stream jack and bore work. Photo on the right shows sheet piling being installed in the streambed. 6/20/06**

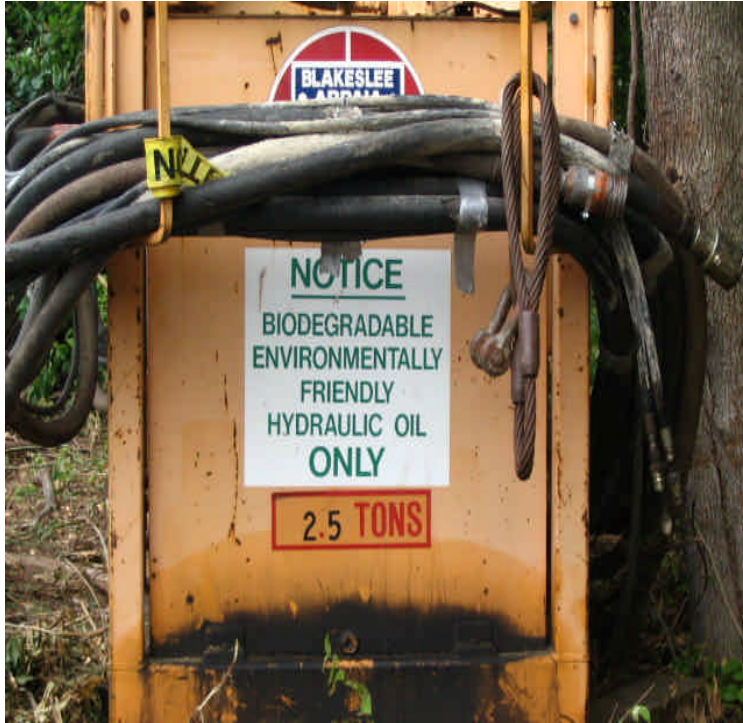
Photo on the left shows one of the generators being used on site. It runs on biodegradable oil. Photo on the right shows a boom across the stream in an effort to filter out any turbidity resulting from the work. 6/20/06

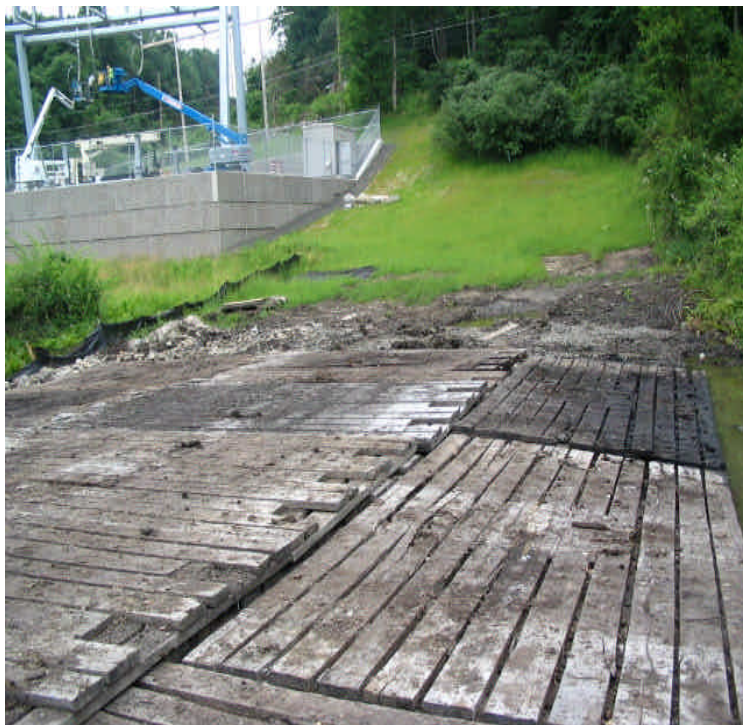
Photo on the left shows timber mats in place at the Hoyts Hill wetland off Rt. 58. Access is needed in this area again, but not for 345kV XLPE work. Photo on the right shows some of the active trenchwork along Rt. 58. All catch basins are protected with fabric in this area. 6/20/06
